# KENTUCKY TRANSPORTATION CENTER

**MAINTENANCE PAINTINGS OF  
VARIOUS BRIDGE PROJECTS  
DURING 2001-2002  
Kentucky Highway Investigative Task #42**

**Research Report  
KTC-03-04/KH42-01-1F**

**Maintenance Painting of Various  
Bridge Projects During 2001-2002**

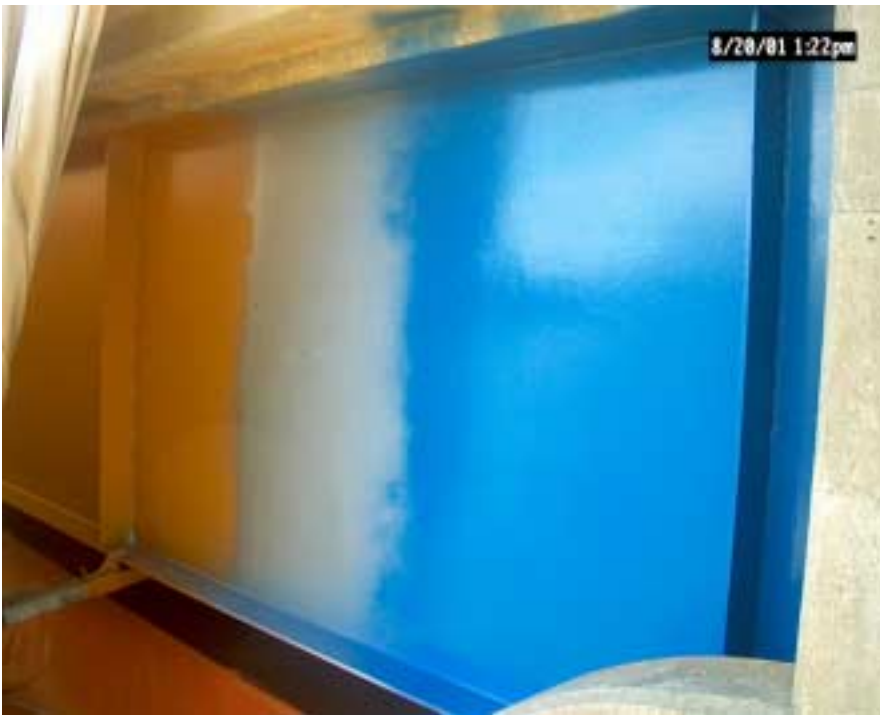
Figure 25. The completed test patch the three specified coats of paint. Note the color contrast.

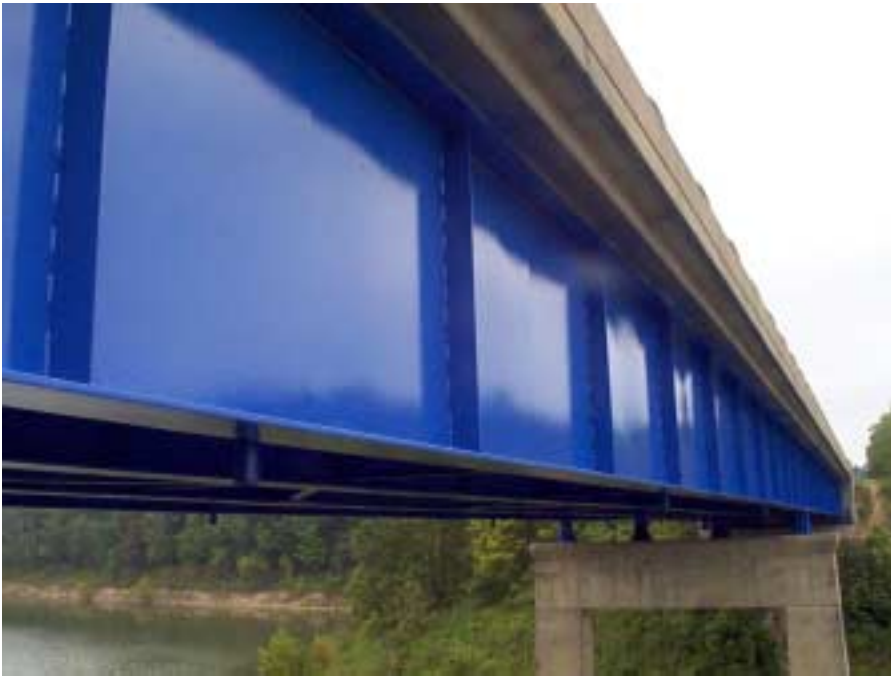
Figure 28. The completed experimental coating during the final inspection of the bridge.

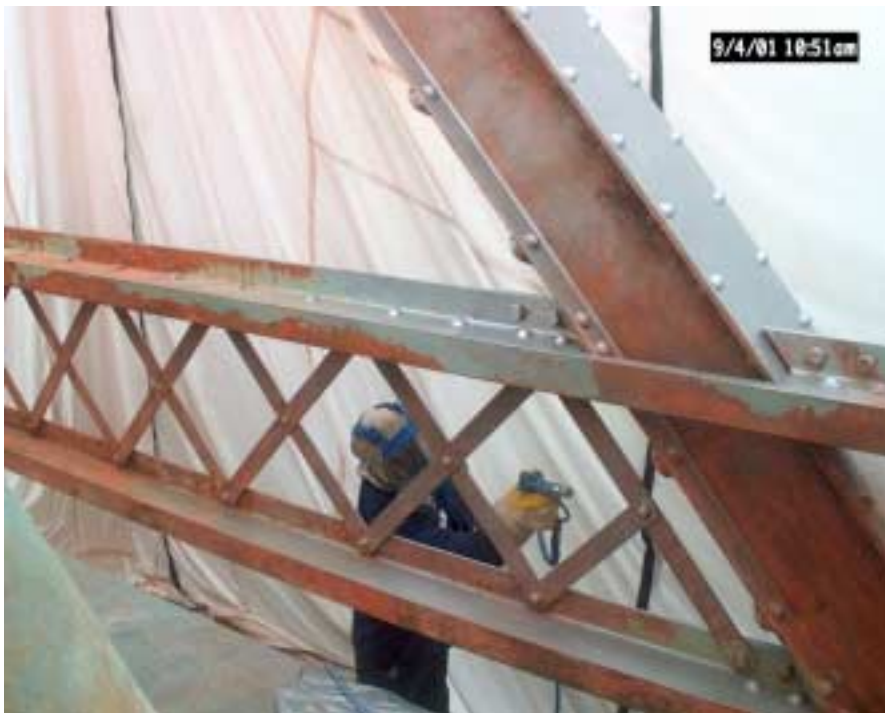
Figure 30. The test patch area prepared for paint application.

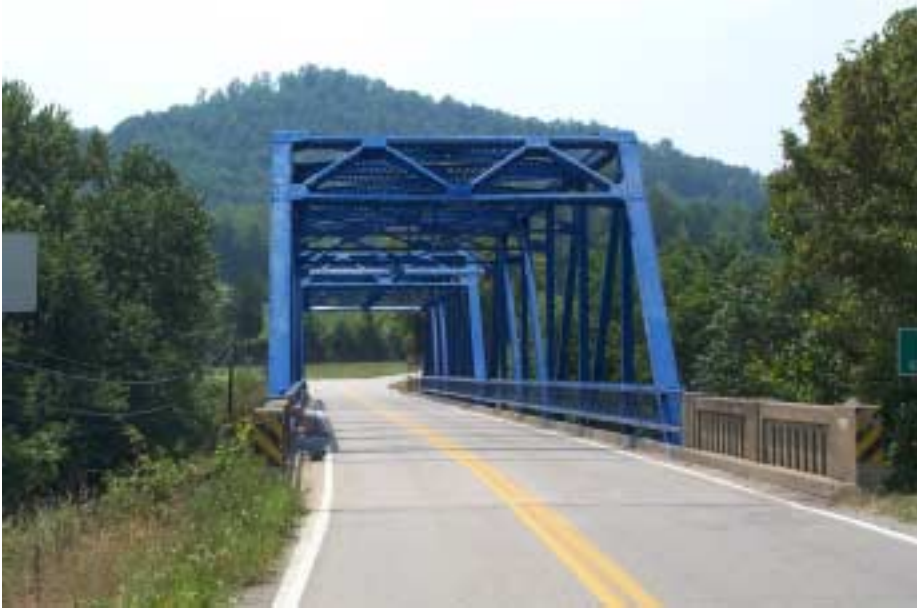
Figure 33. The bridge on KY 30 after painting was completed.

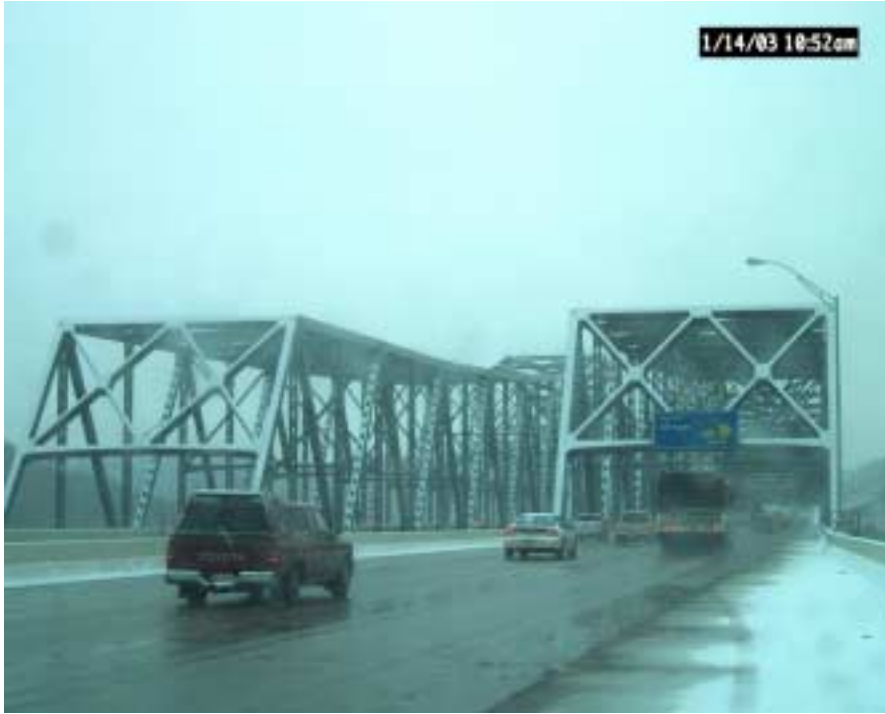
The Special Notes and Standard Specifications were followed throughout the cleaning and painting of bridges B00040, B00040P, B00041 and B00041P. Most areas indicate that SP3 was obtained during cleaning of the bridge. All coats of paint were applied to meet the specifications of this project. All work inspected was completed within conformance of the Standard Specifications and Special Notes applicable to this project.

Figure 45. The twin bridges on I-275 in Campbell County after painting.

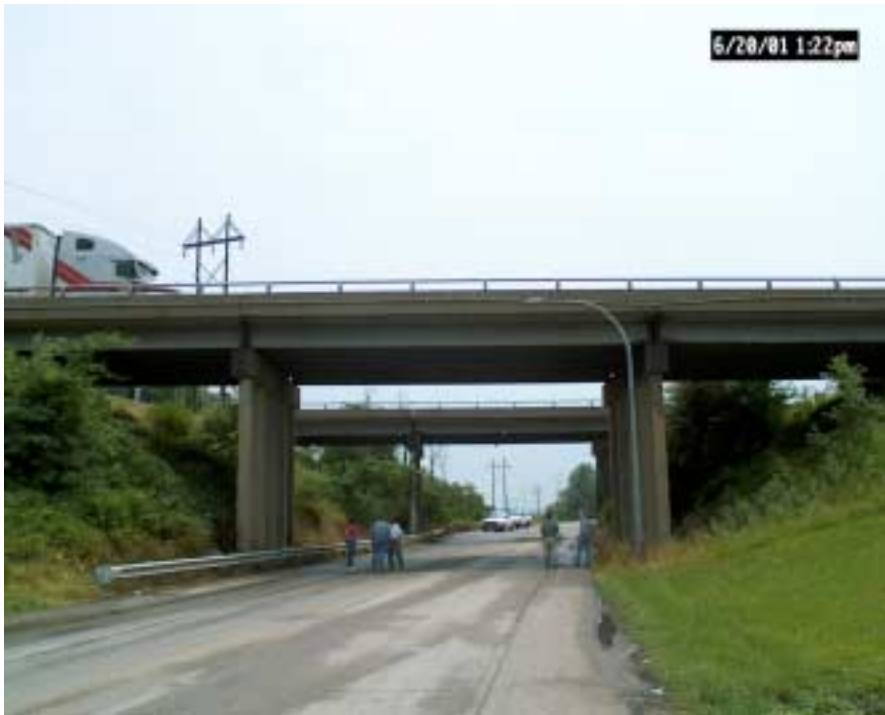
Figure 46. View of the bridges in Daviess County before painting.

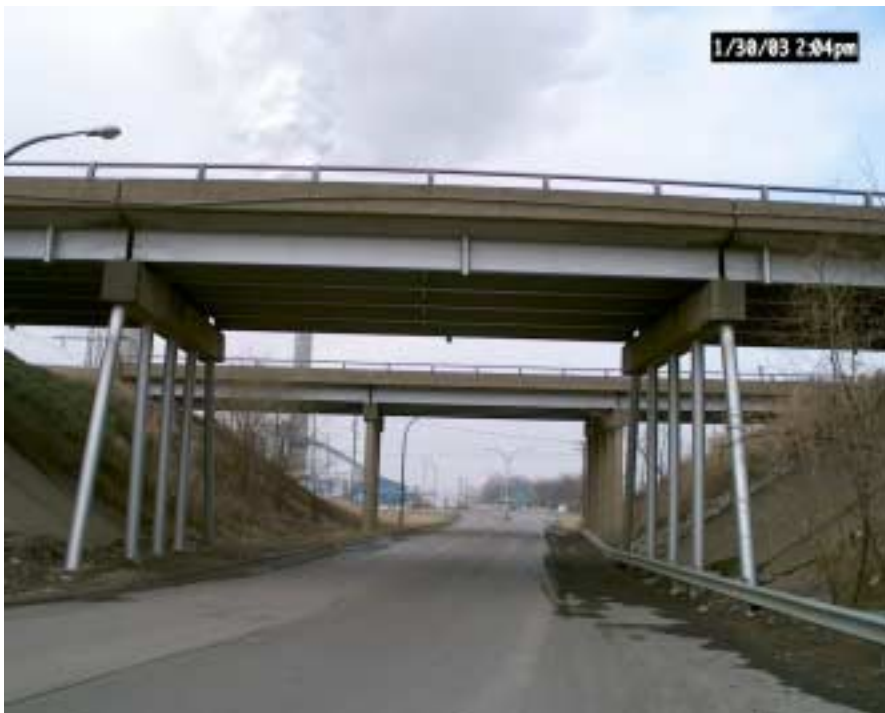
Figure 47. View of the bridges in Daviess County after painting.

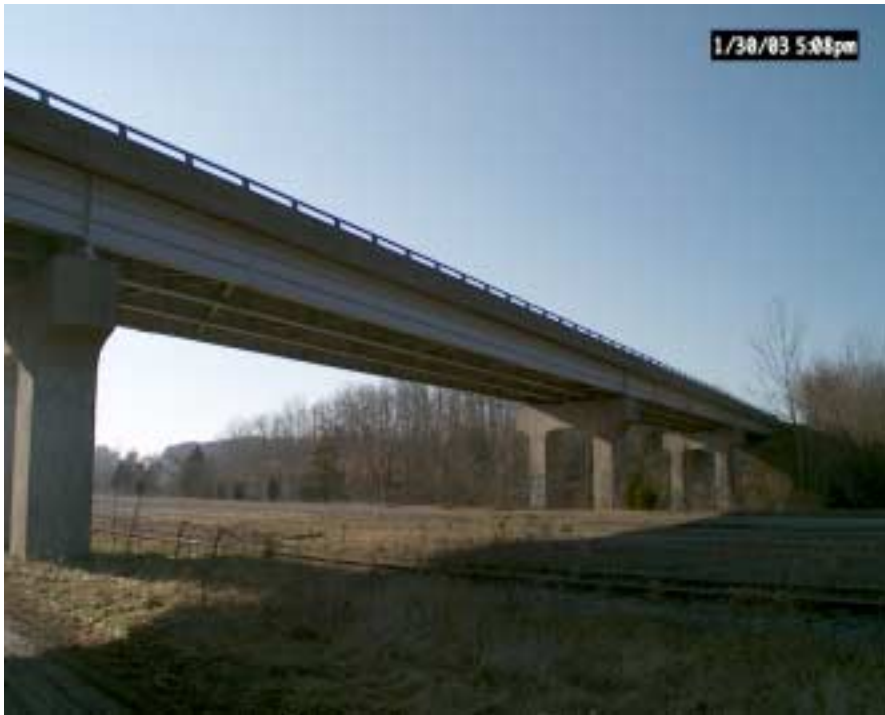
Figure 48. View of KY 453 Bridge in Livingston County after painting.

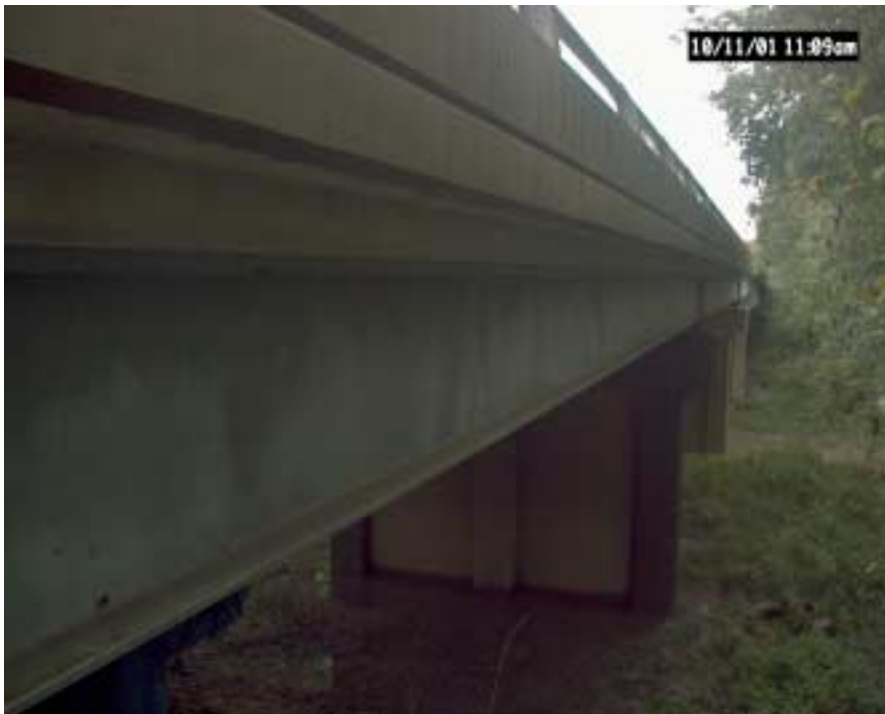
Figure 49. View of KY 131 Bridge in McCracken County before painting.

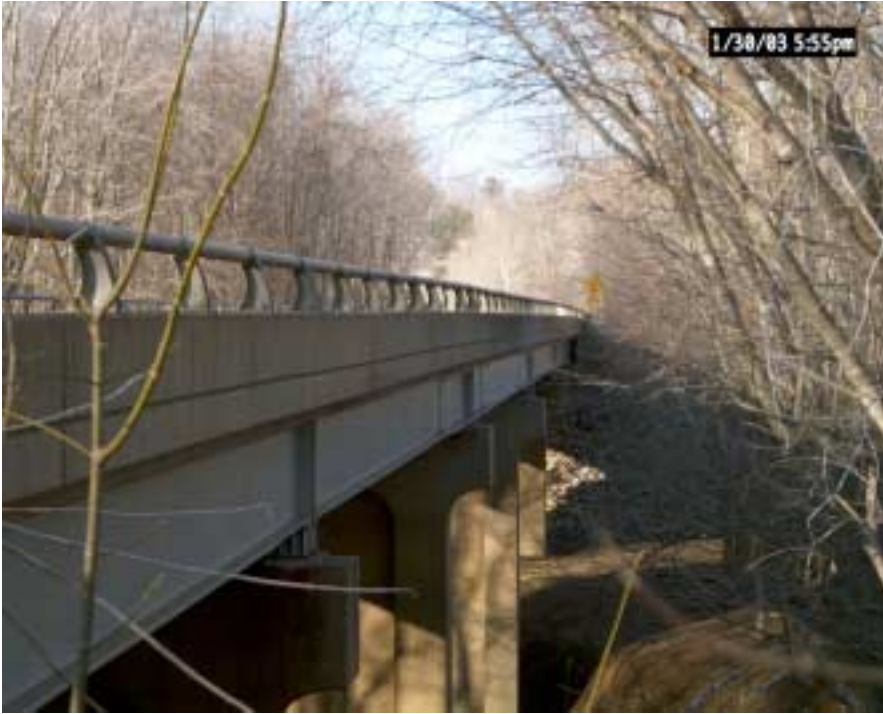
Figure 50. View of KY 131 Bridge in McCracken County after painting.

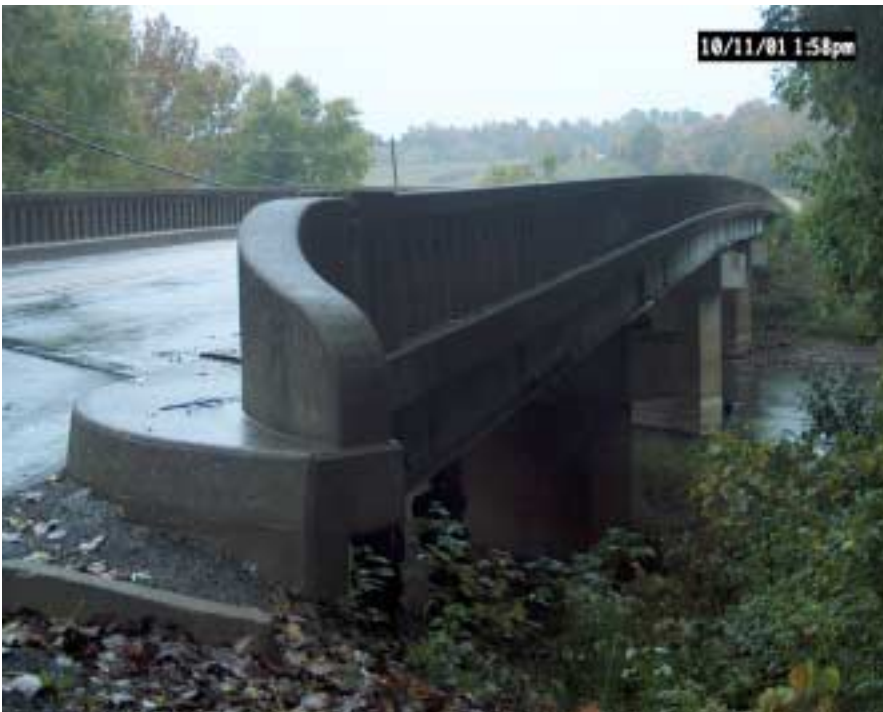
Figure 51. View of KY 139 Bridge in Trigg County before painting.

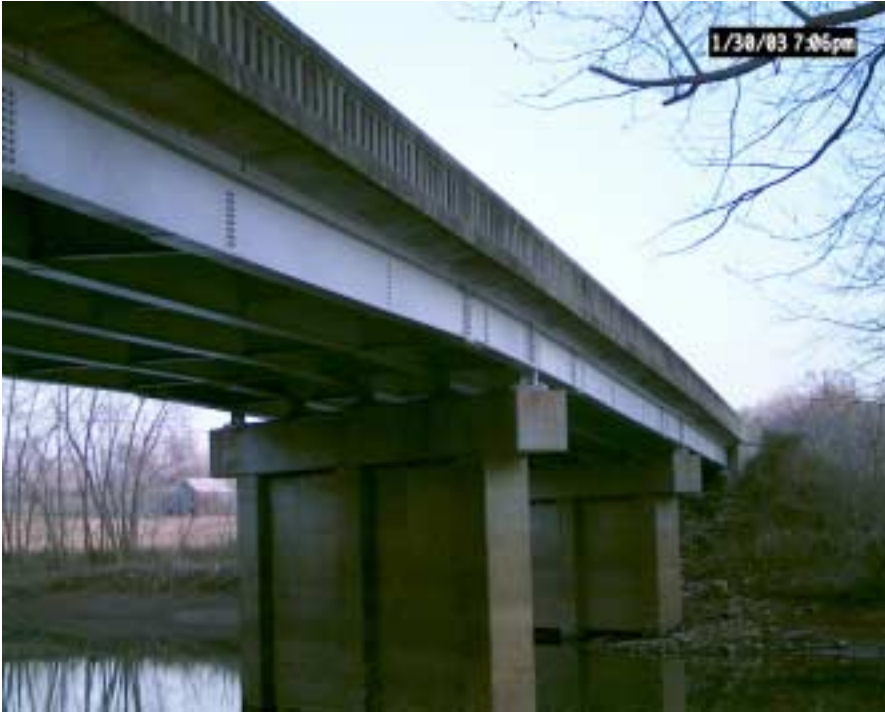
Figure 52. View of KY 139 Bridge in Trigg County after painting.

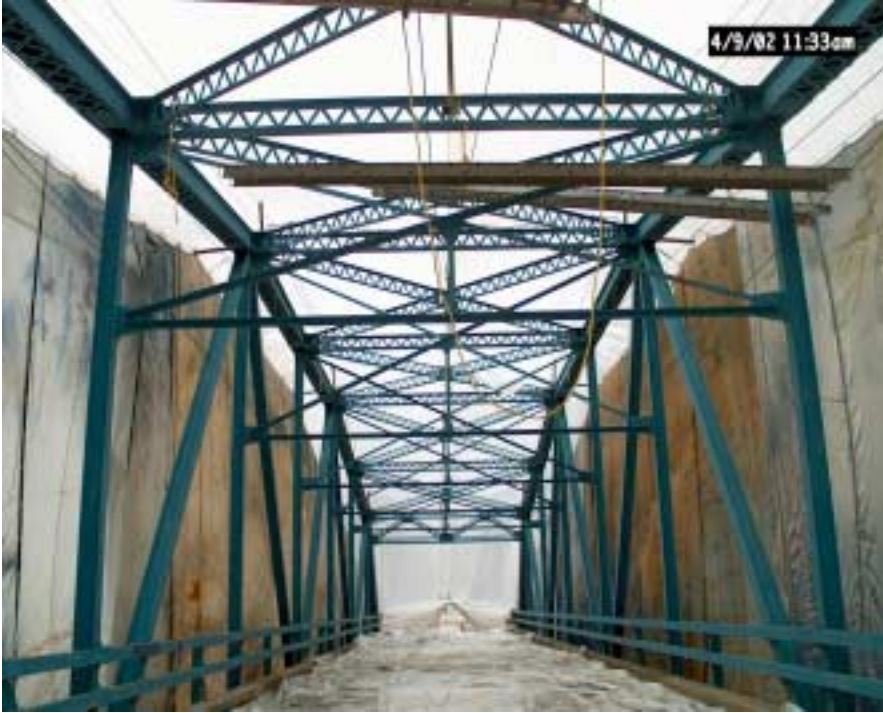
Figure 53. View of KY 1661 Bridge in Carter County before painting inside the containment.

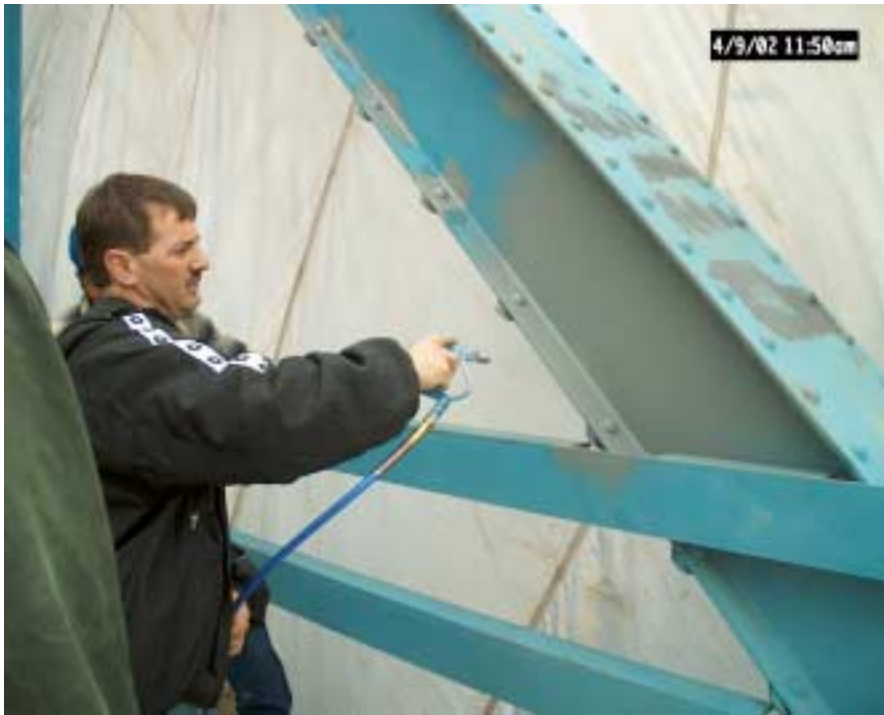
Figure 54. Contractor applying prime coat to the test patch area on KY 1661 Bridge in Carter County.

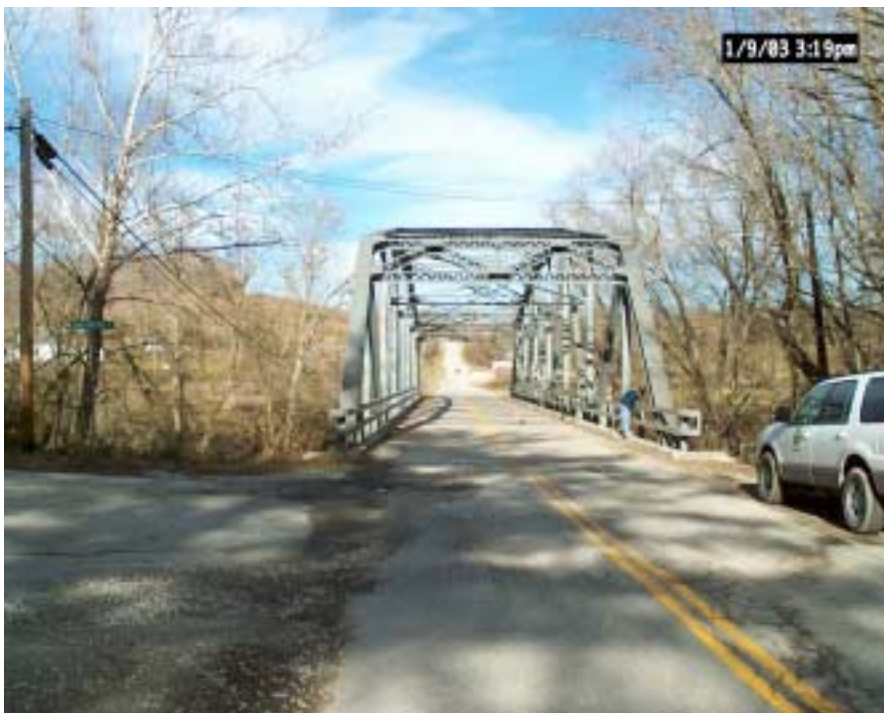
Figure 55. View of KY 1661 Bridge in Carter County after painting.

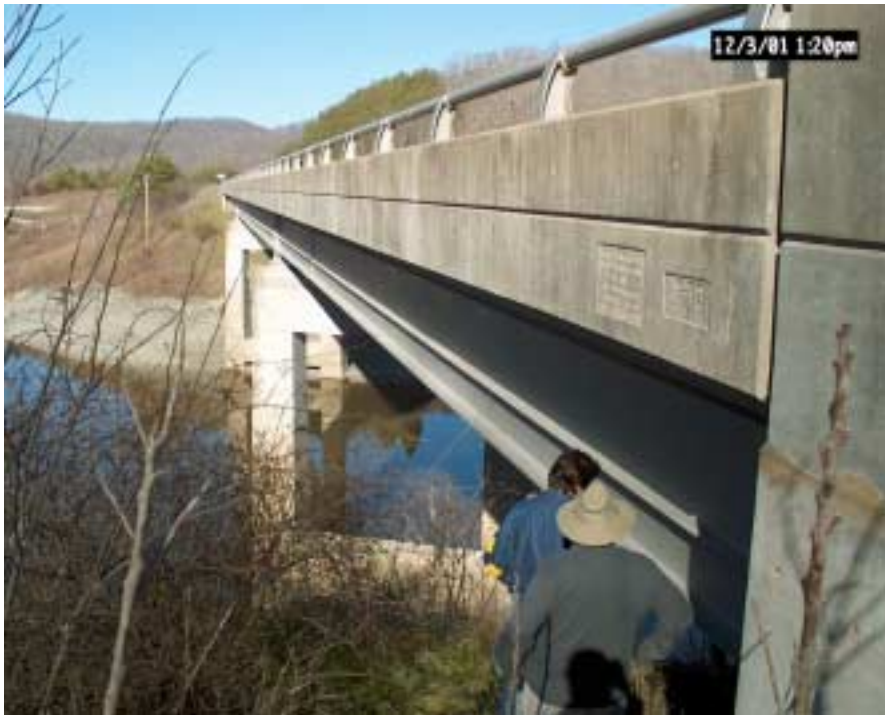
Figure 56. View of KY 519 Bridge in Rowan County before painting.

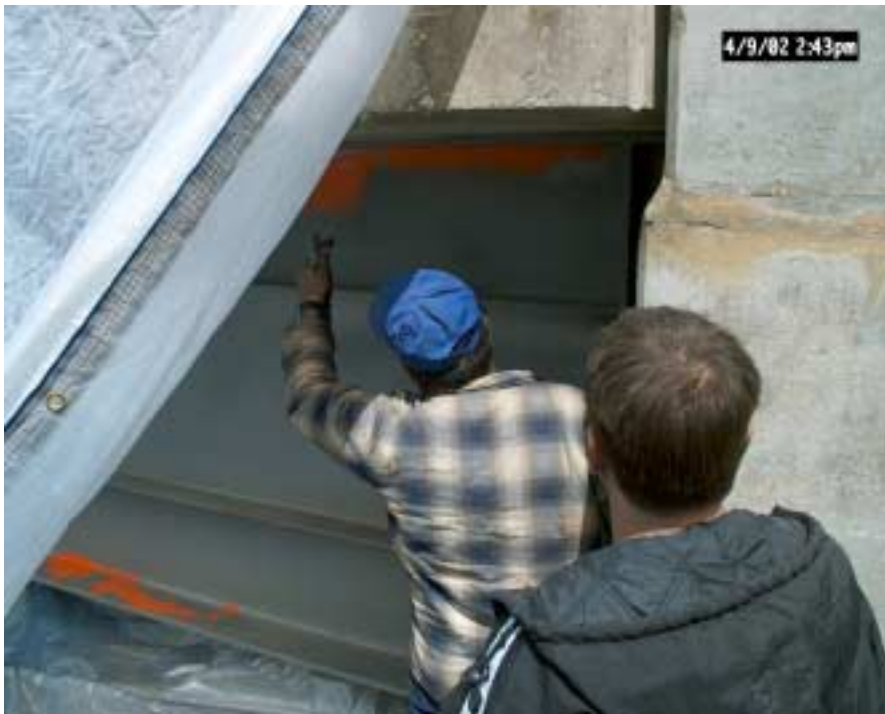
Figure 57. Contactor applying coating on the test patch on KY 519 Bridge in Rowan County.

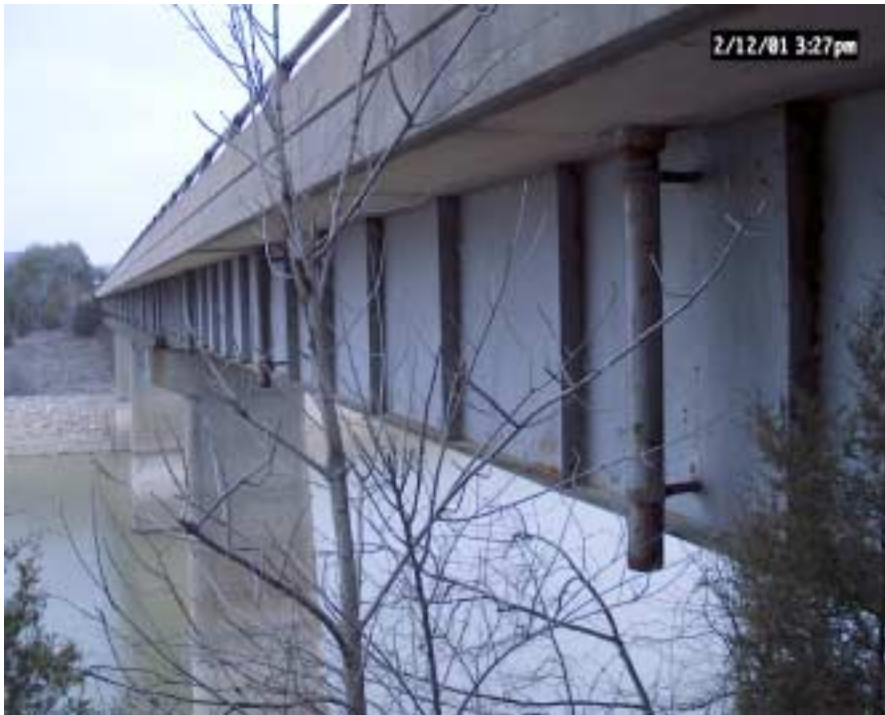
Figure 58. View of KY 88 Bridge in Hart County before painting.

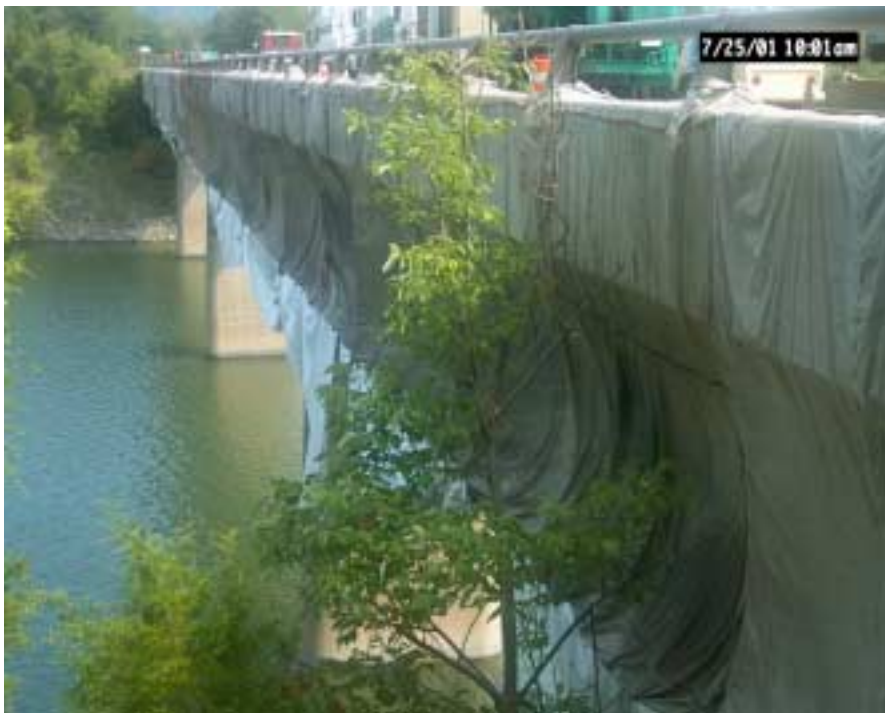
Figure 59. Containment used on KY 88 Bridge in Hart County.

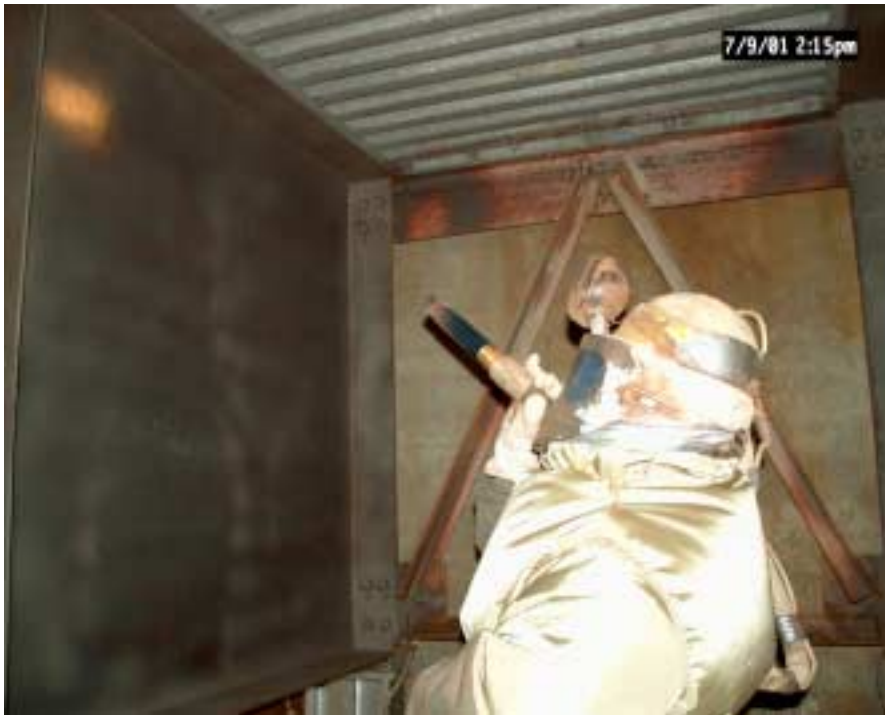
Figure 60. Contractor abrasive blasting steel on KY 88 Bridge in Hart County.

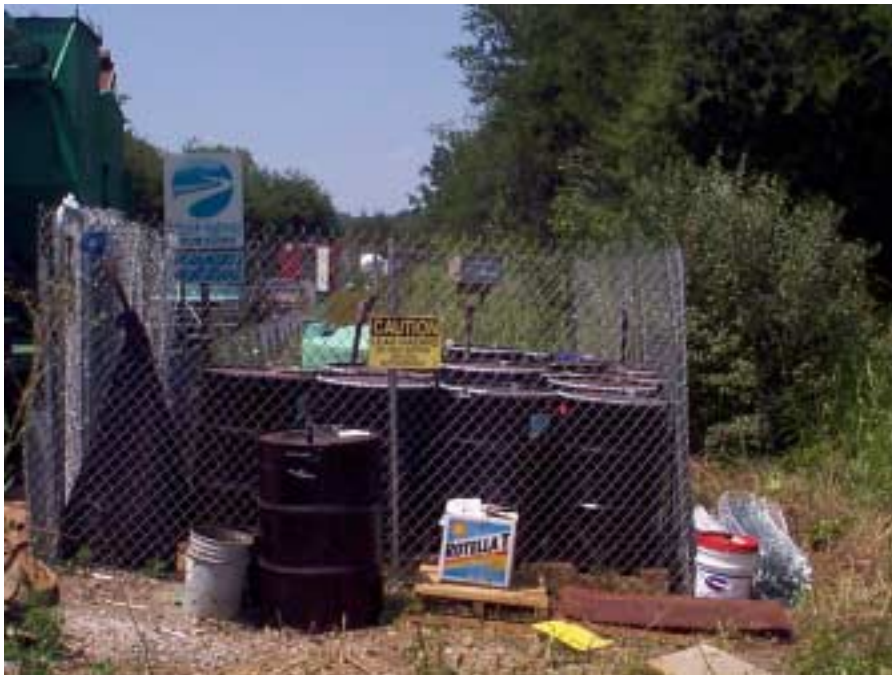
Figure 61. The hazardous waste storage site for the KY 88 Bridge in Hart County.

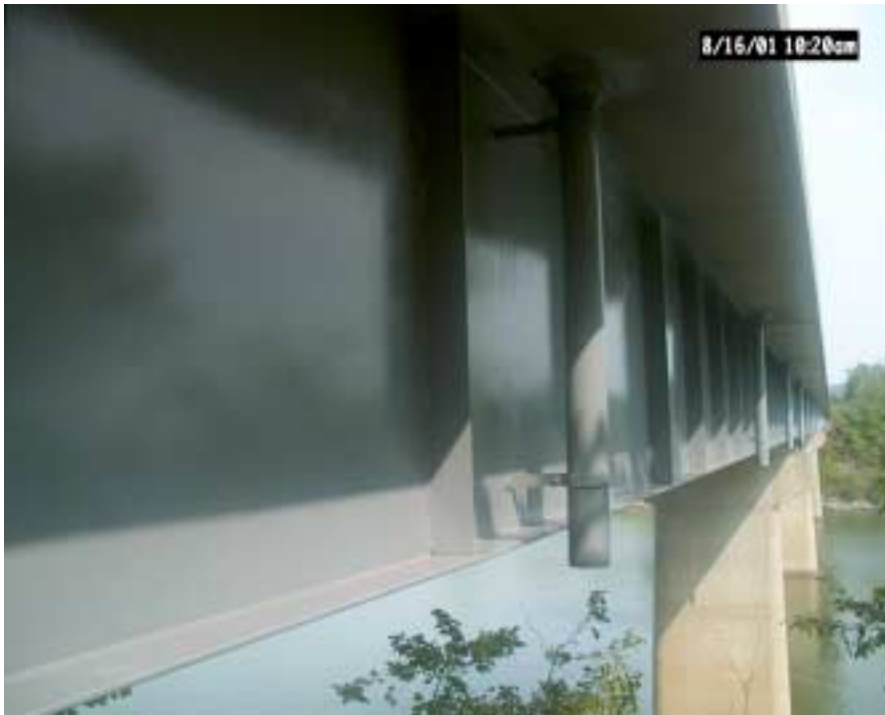
Figure 62. View of KY 88 Bridge in Hart County after painting.

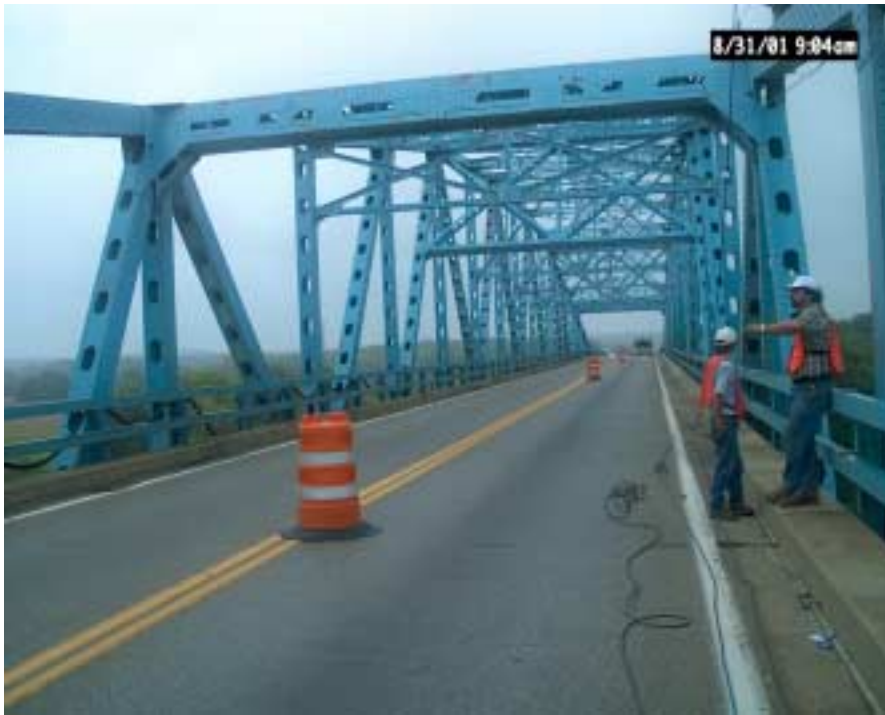
Figure 63. View of US 62 Bridge in Livingston County before painting.

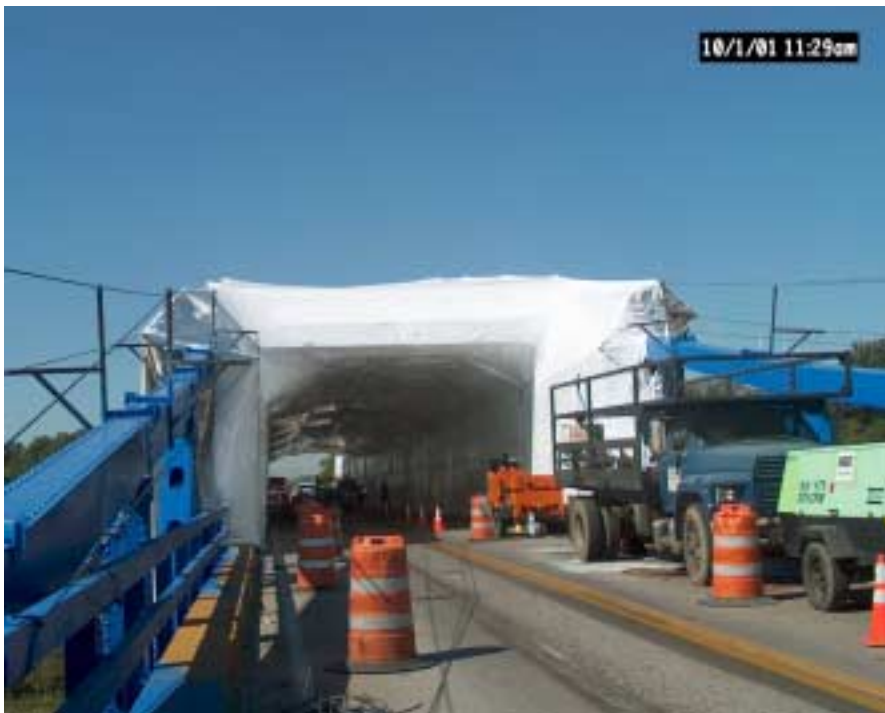
Figure 64. Containment used on the US 62 Bridge in Livingston County.

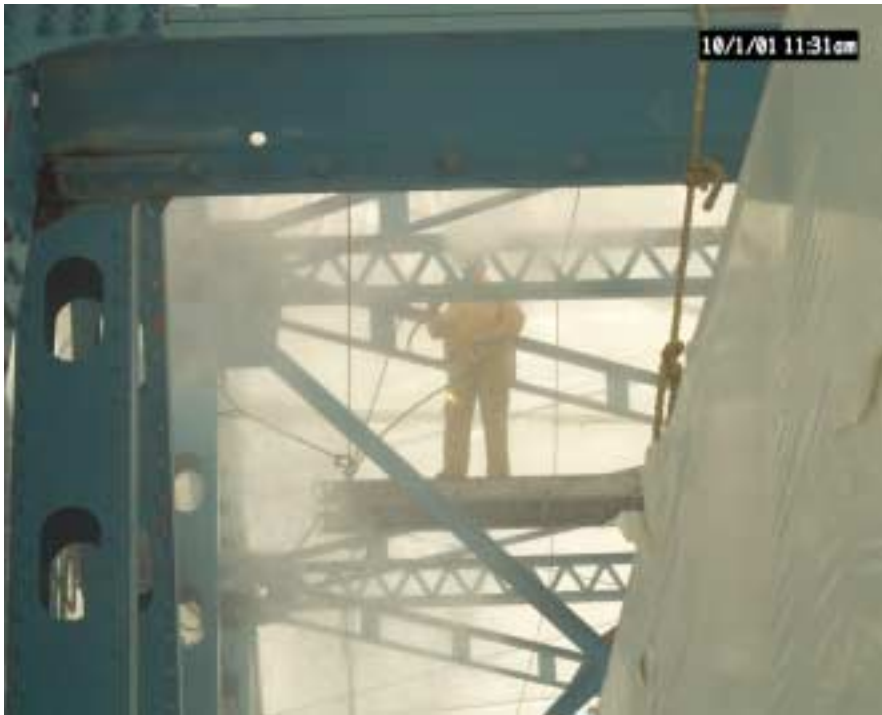
Figure 65. Contractor performing washing operation on the US 62 Bridge in Livingston County.

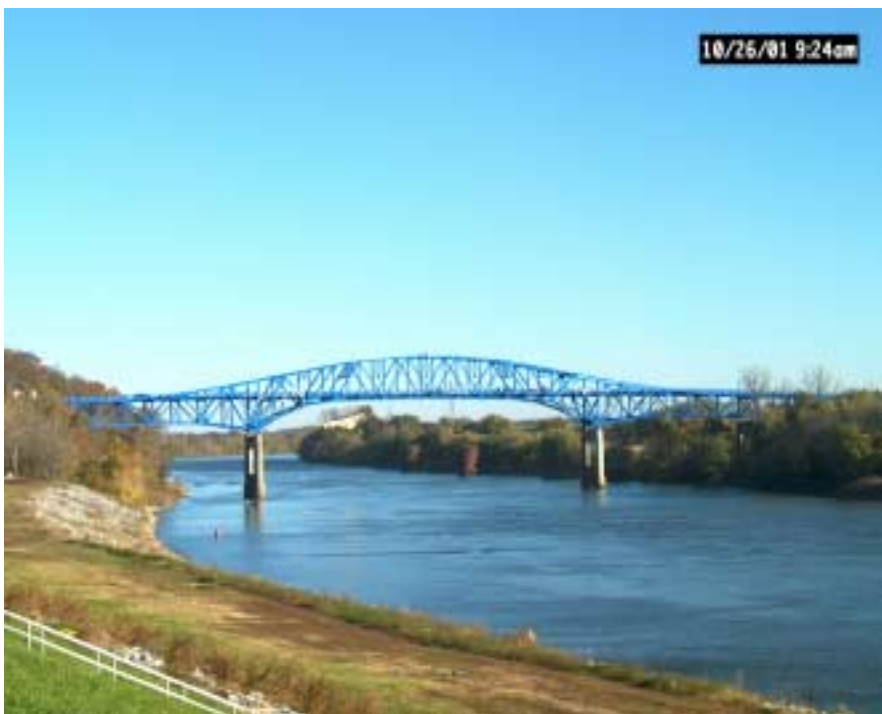
Figure 66. View of US 62 Bridge in Livingston County after painting.

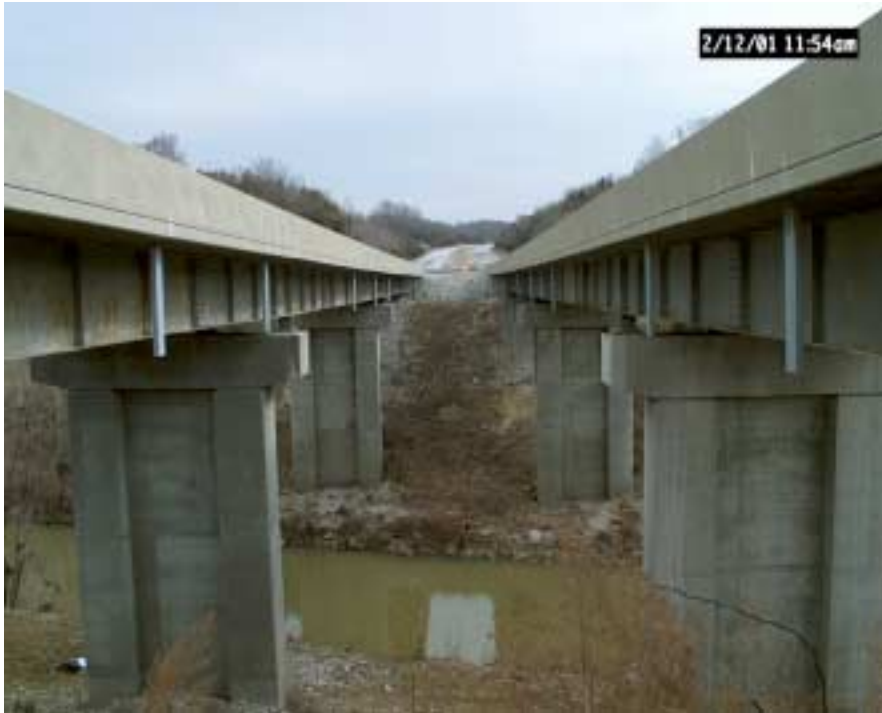
Figure 67. View of the bridges on KY 9002 in Nelson County before painting.

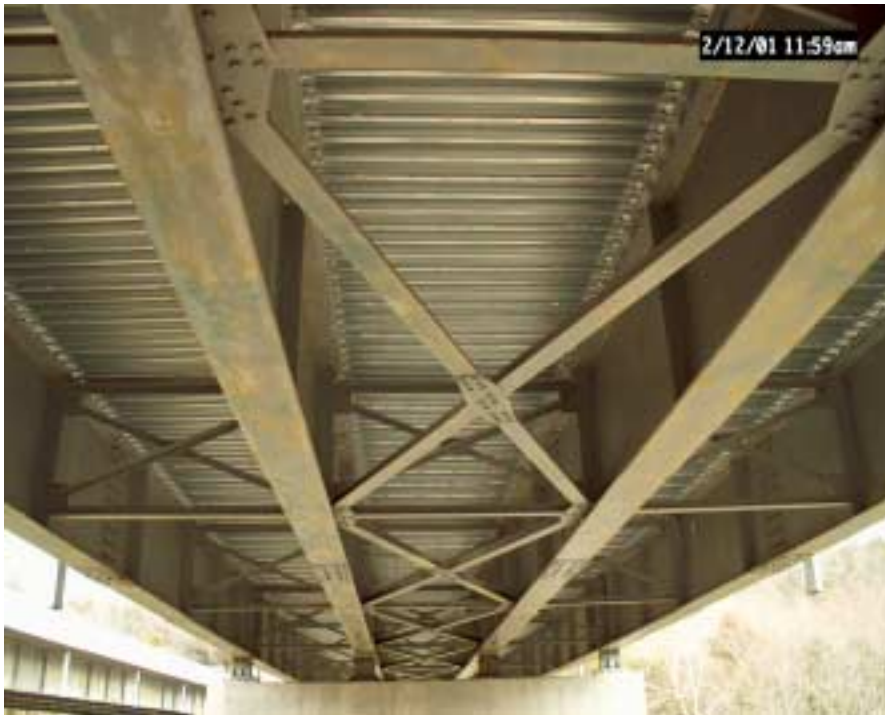
Figure 68. View of the under side of the bridge on KY 9002 in Nelson County before painting.

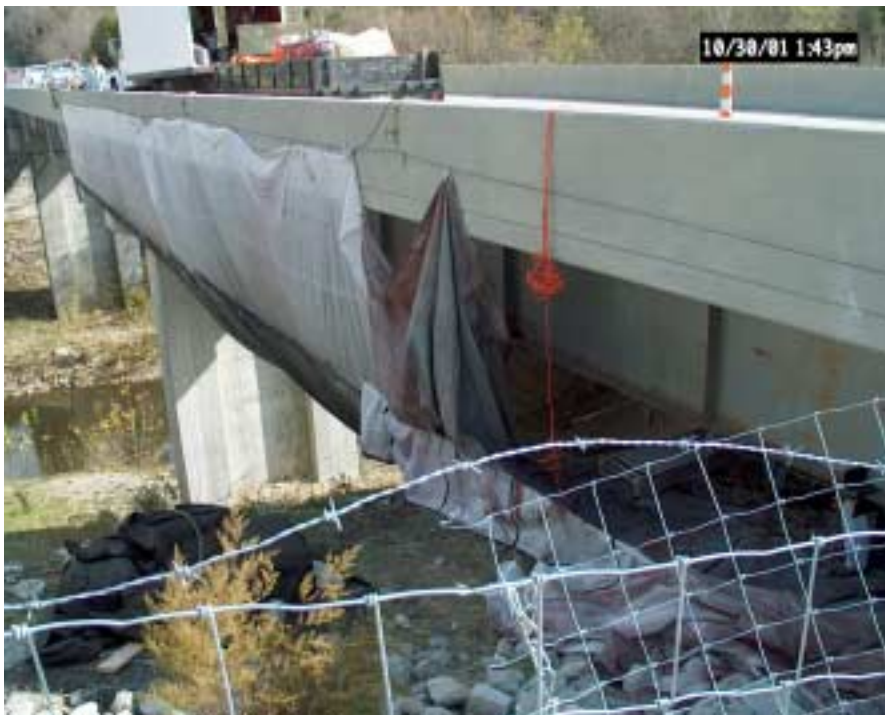
Figure 69. Containment used on KY 9002 Bridge in Nelson County.

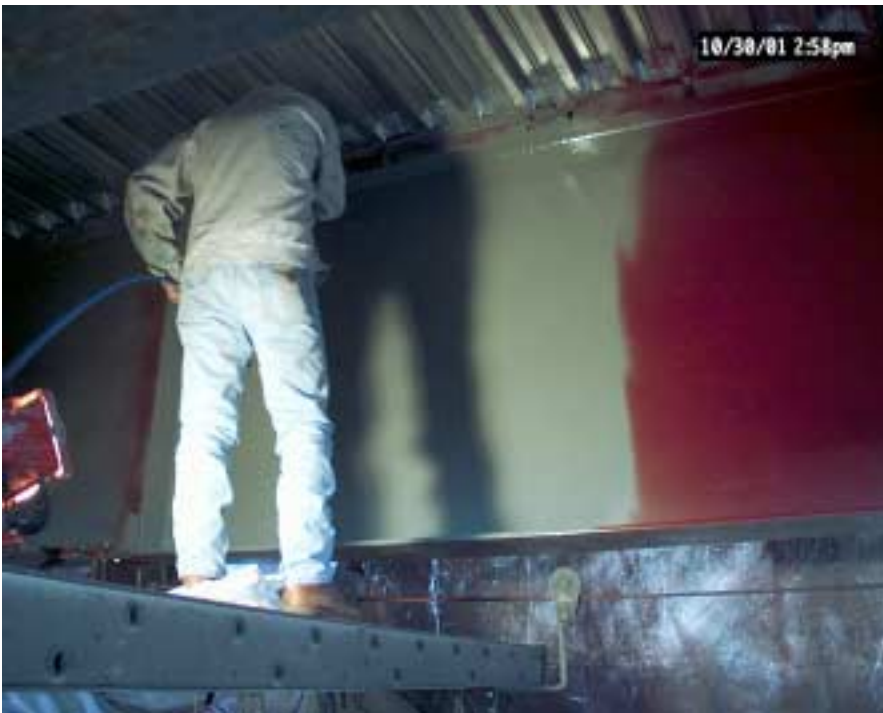
Figure 71. Contractor applying coating to the test patch area.

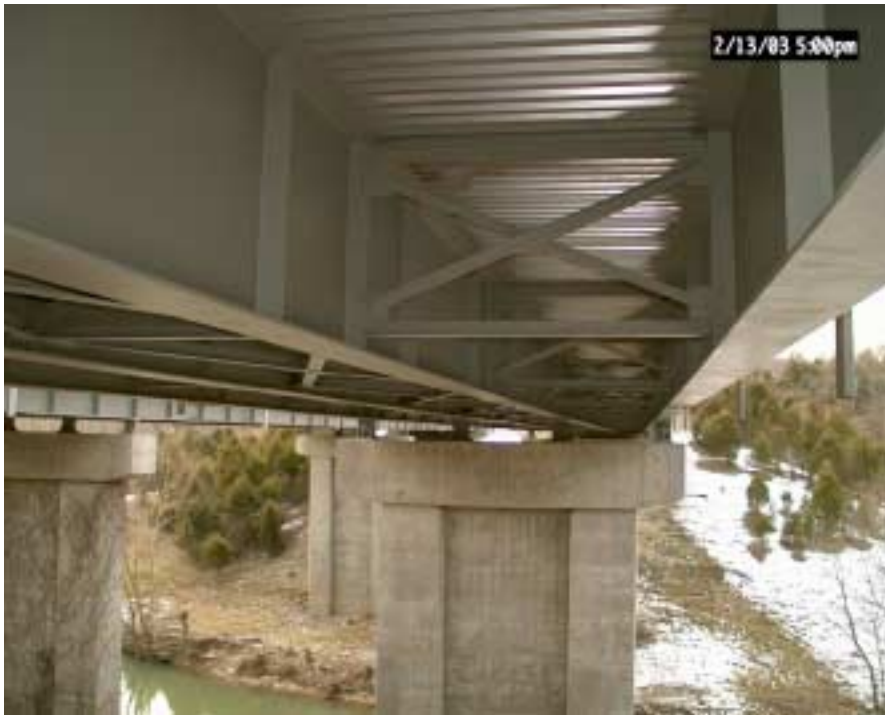
Figure 72. View of under side of KY 9002 Bridge in Nelson County after painting.

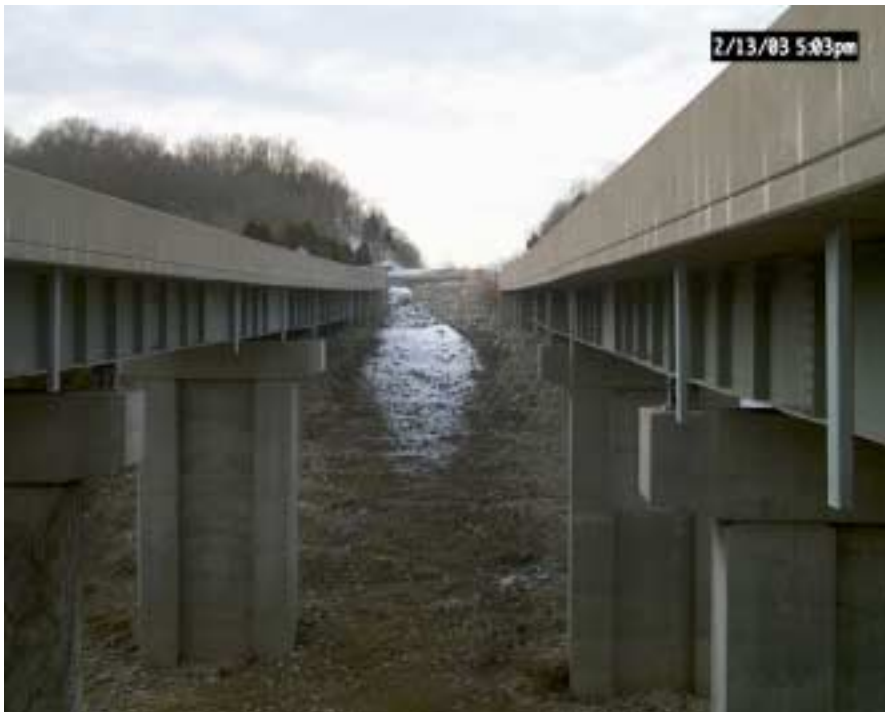
Figure 73. View of KY 9002 Bridges in Nelson County after painting.

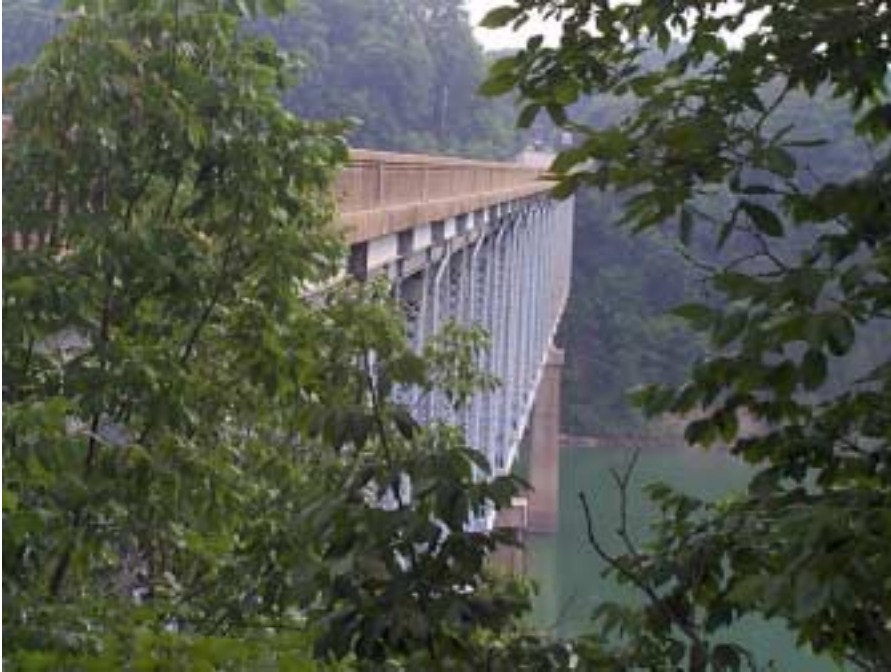
Figure 74. View of the KY 80 Bridge in Pulaski County before painting.

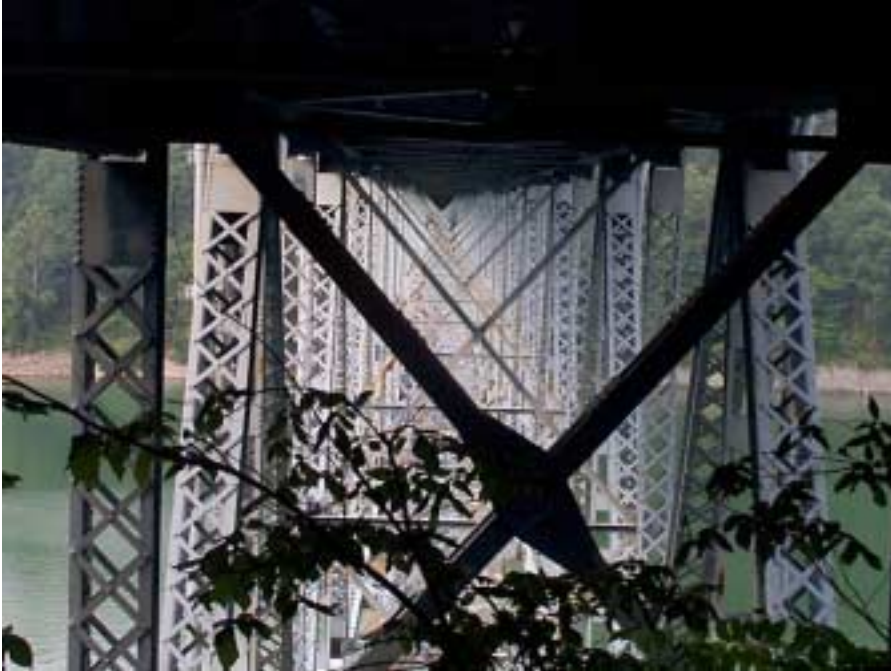
Figure 75. View of the under side of KY 80 Bridge in Pulaski County before painting.

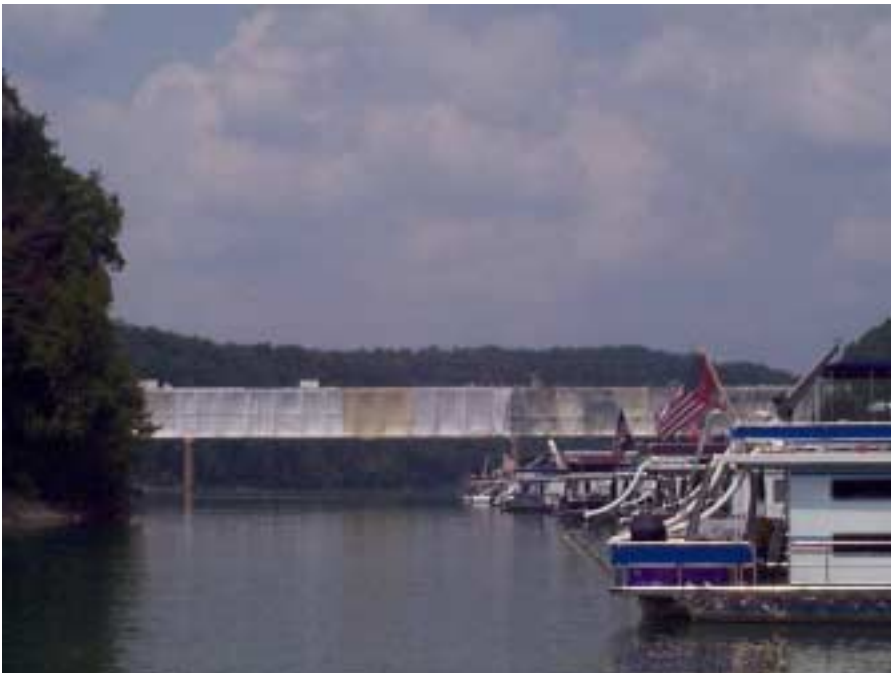
Figure 76. The bridge on KY 80 in Pulaski County showing the containment.
